Use of Coatings on Hydraulic Steel Structures

Part 2—Supplemental Information

PURPOSE AND INTRODUCTION: This technical note is the second in a two-part series that contains information about coatings systems and coating conditions that exist within the U.S. Army Corps of Engineers (USACE or Corps) and U.S. Bureau of Reclamation (USBR). This second volume focuses on common coating problems, special topics related to coatings, and specific examples encountered in the field survey.

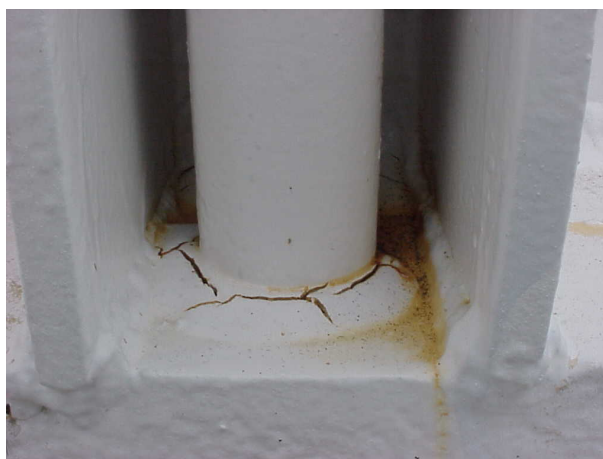
Figure 1. Example of failure due to excessive thickness.

Examples of coating problems include: excessive thickness that causes cracking (Figure 1) or too thin of a coating (Figure 2), corrosion that occurs near bolts, rivets, welds, and other surface irregularities (Figure 3), entrained air that occurs during spray application of the coating (Figure 4), and impact from objects or debris (Figure 5).

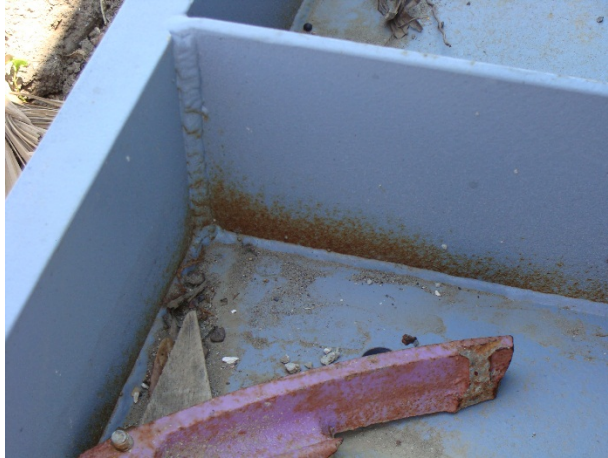
Figure 2. Example of failure from too thin of a coating.

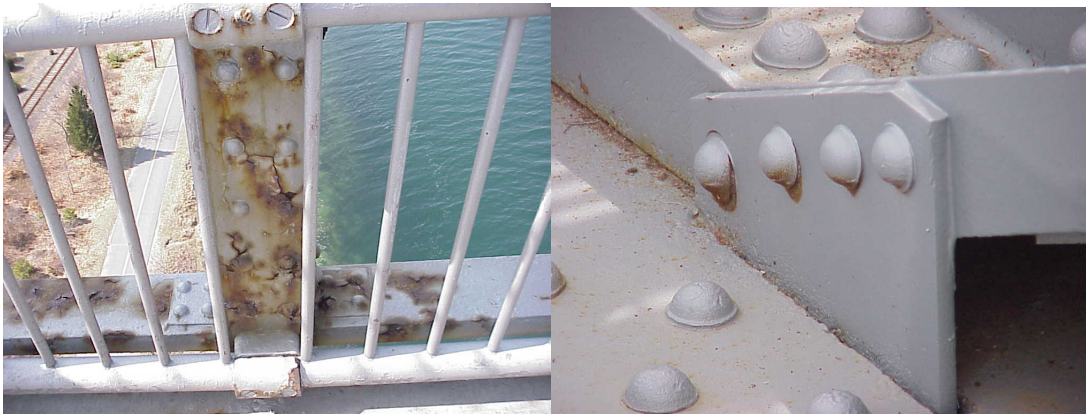
Figure 3. Examples of failure near bolts, rivets, and welds.

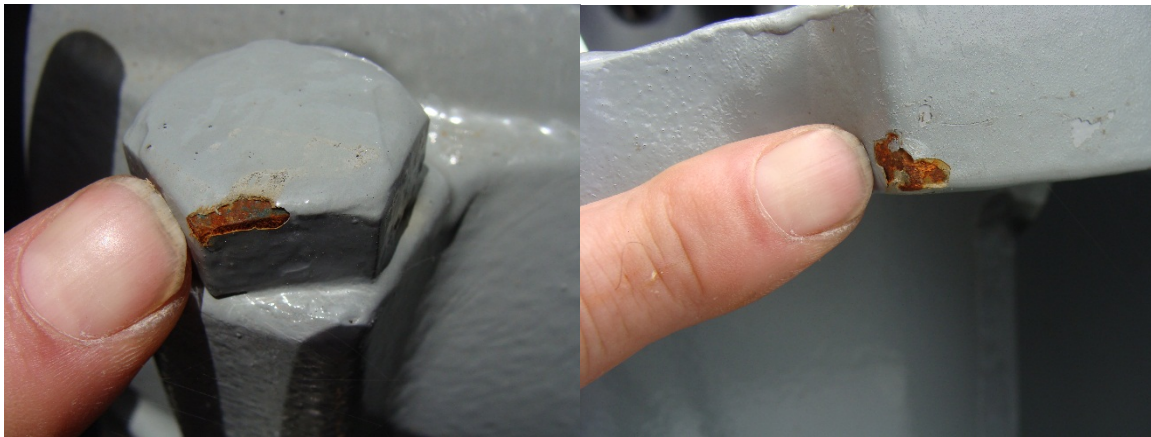
Figure 6. Examples of failure of epoxy coating due to edge chipping.

Typical coating failures include: epoxies chipping when brittle and worn corners and edges of machinery are impacted (Figure 6) and loss of thickness due to chalking. Other coating failures caused by the environment include: erosion, abrasion, corrosion under the coating, undercutting along the steel/coating interface, and delamination in debris-filled high-flow water.
